PCEI Invoice Final Report February 2011

South Fork Clearwater River Watershed Riparian Restoration Project Kirtner Property and Rylaarsdam property

Watershed: South Fork Clearwater River
Stream Name: South Fork Clearwater River
Project Start Date: 5/15/2006
Project End Date: 10/01/2010
Project Status: Complete
Project Code: WCW1
Contract Numbers: S180

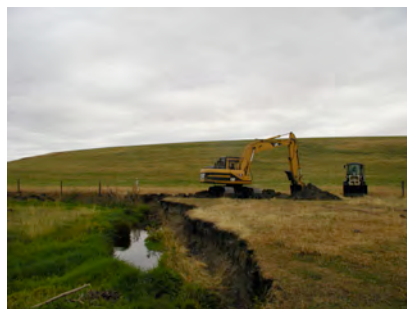
October 2006: Newly constructed point bar. The restoration plan was designed to mimic the natural meanders of the creek. Stream bank slopes were resloped to a minimum 3:1 in most places.

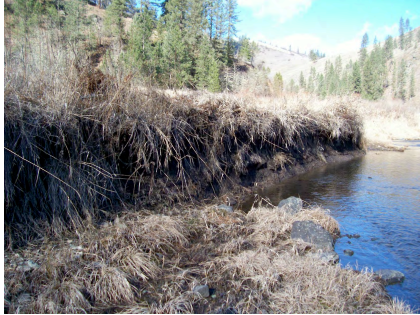
Pre-Restoration

Kirtner, October 2005: Eroding bank with be stabilized during restoration efforts in order to reduce sediment loading to the South Fork Clearwater River.

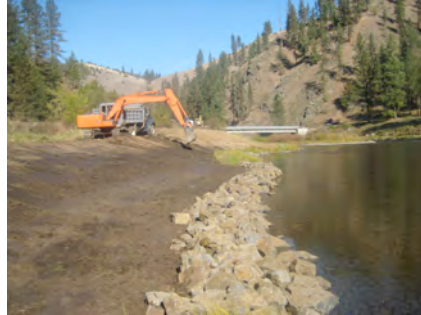
Construction Phase

Kirtner, October 2010: Banks stabilized with 3:1 slopes and a rock toe.

Excavation activities began on September 24, 2010 and were complete on September 29, 2010. The banks were resloped to between a 2:1 and 3:1 grade. A rock toe was installed and integrated into the bank just at water level to protect the bank and mimic the existing bank conditions on nearby banks.

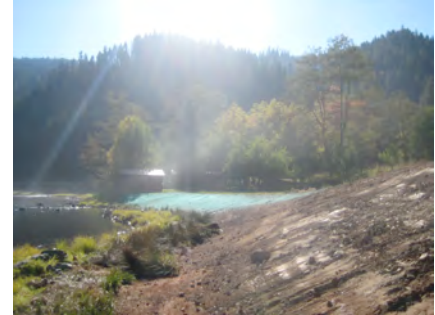
Planting Phase

Kirtner, October 2010: Sedge mats were installed to help strengthen the toe and stabilize the banks.

Thirty-three sedge mats were installed the entire length of the project. The sedge mats will help stabilize newly sloped banks and add to the function and aesthetics of the project. The project site was hydro-seeded with a restoration mix on September 30. A group of students from the Grangeville school district planted **361 native trees and shrubs** on the banks and top of bank throughout the project site.

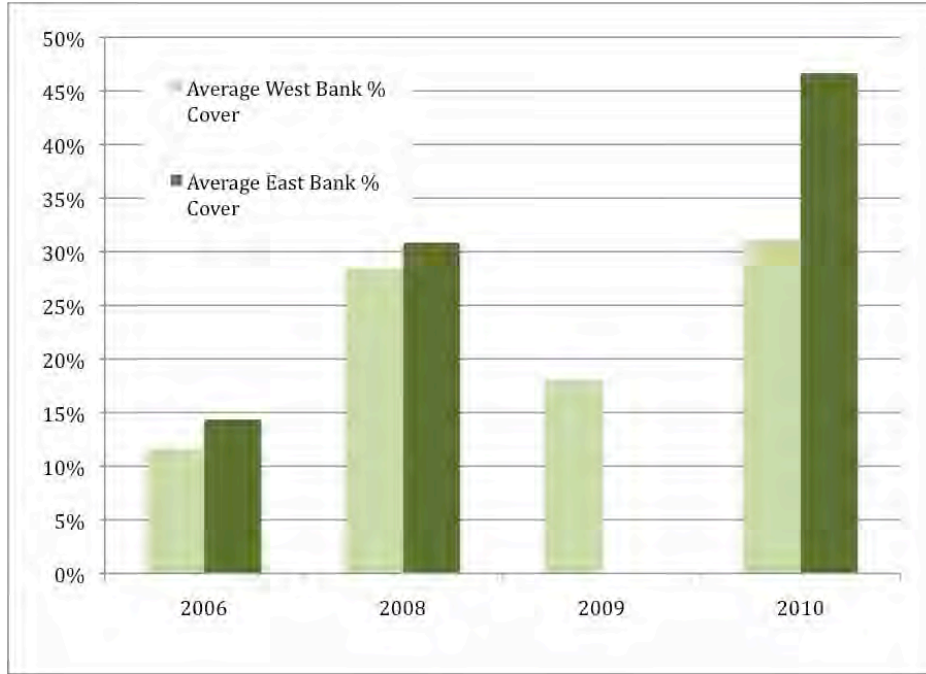
Figure 2: Vegetative Cover

Vegetative canopy data was also assessed throughout the course of the project (Figure 2). The figure indicates a noticeable upward trend in increased canopy from 2006 to 2010. While PCEI would like to see the increasing canopy cover trend continuing, four years is not enough time to evaluate canopy cover success.

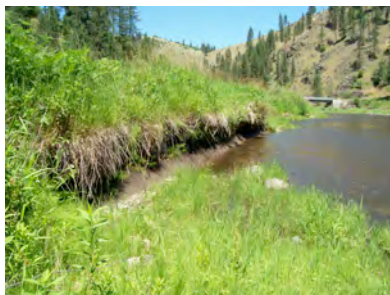
Photo Point 1 Downstream

**Pre-Restoration
June 2006**

Actively eroding banks with severe undercut with great potential for sediment loading to the South Fork Clearwater River.

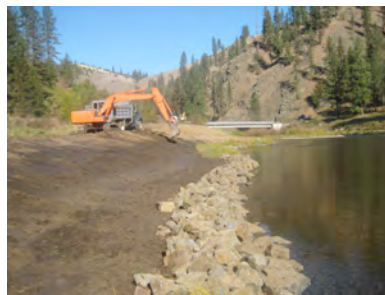
**During Excavation
September 2010**

Excavator shapes banks. The constructed rock toe connects and mimics the native bank makeup.

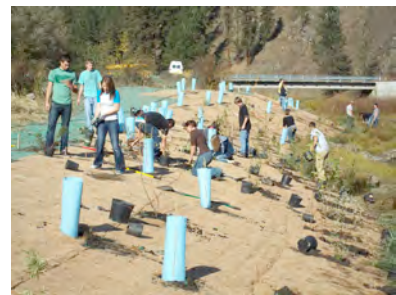
**Post Excavation
September 2010**

Students from Grangeville help plant trees and shrubs. The erosion control fabric will help the restoration seed mix germinate and adhere to the banks.

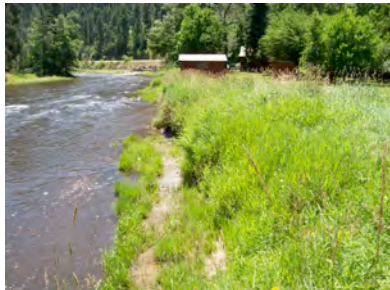
Photo Point 2 Upstream

**Pre-Restoration
July 2006**

Looking upstream, the intact rock and sedge toe is noticeable, and the undercut bank extends to just downstream of the red building.

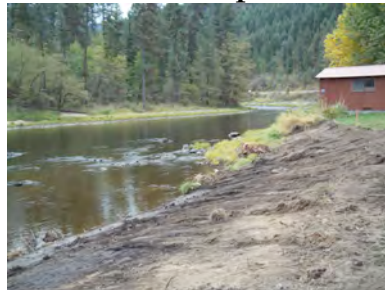
**During Excavation
September 2010**

Excavated banks were sloped to a 3:1 ratio where possible. The native sedge and rock toe is evident near the red out building.

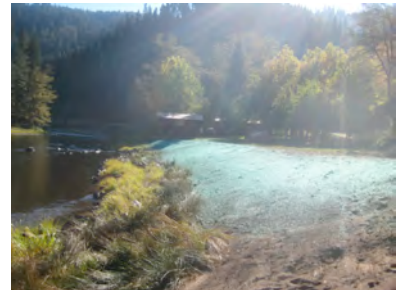
**Post Excavation
September 2010**

Newly sloped banks recently hydro-seeded. Sedge mats installed behind constructed rock toe.
