# Palouse-Clearwater Environmental Institute

Final Project Report

## Friends of Flannigan Creek Restoration Project

Broyles, Lawrence, Panteja, Reynolds, and Rogers properties

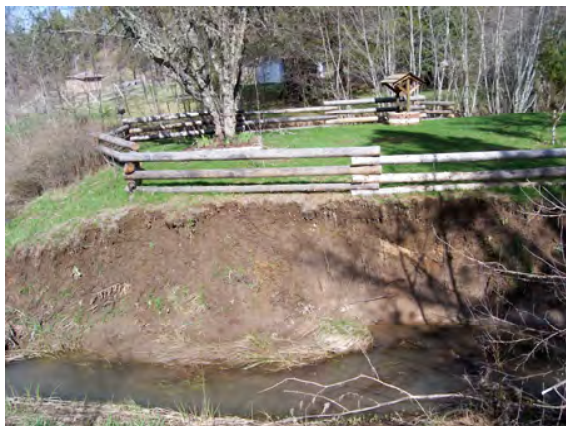
*April 2007: Eroding and incised banks characterize the project reach on Flannigan Creek.*

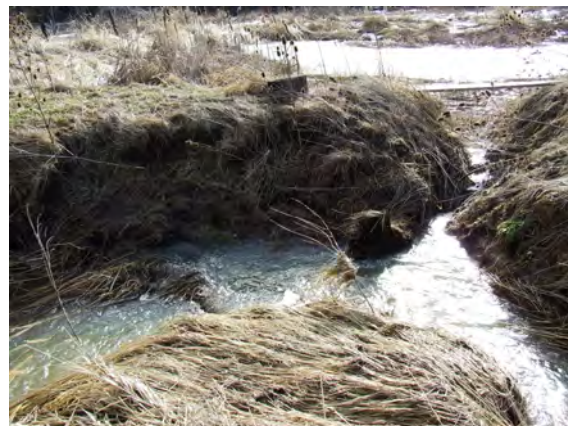
*February 2006: Lack of riparian vegetation has lead to the sloughing of the bank in many areas along the project reach.*

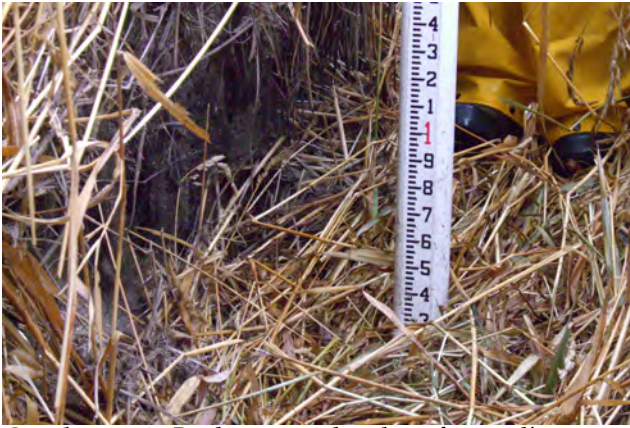
*October 2007: Banks were resloped 3:1 from ordinary high water mark at 2' above streambed.*

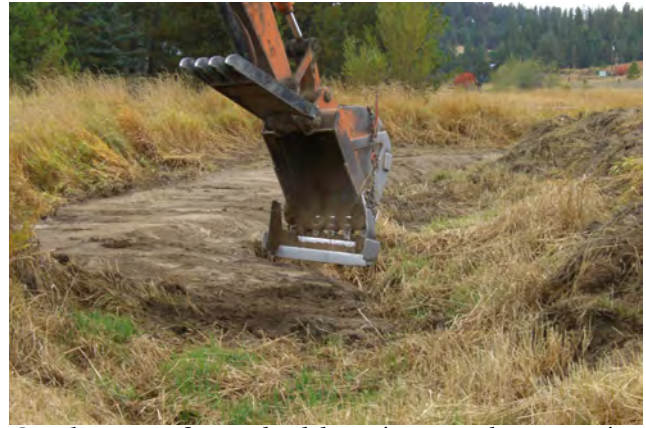
*October 2007: Stream bank berm is removed reconnecting floodplain to the creek.*

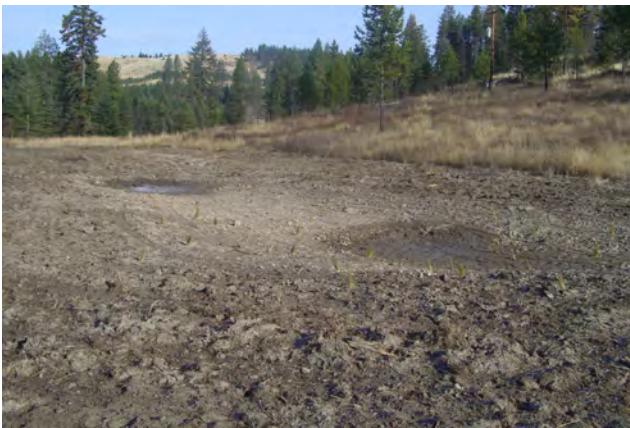
*October 2007: Large wetland was created at the toe of the fire-affected slope to filter overland flows that have increased since a fire that burned up the area 4 years ago.*

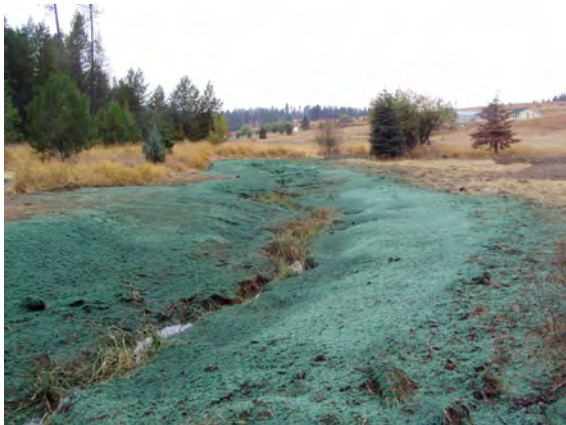
*October 2007: Hydro-mulching was used on site to help increase seed germination rate and to help stabilize banks following excavation activities.*

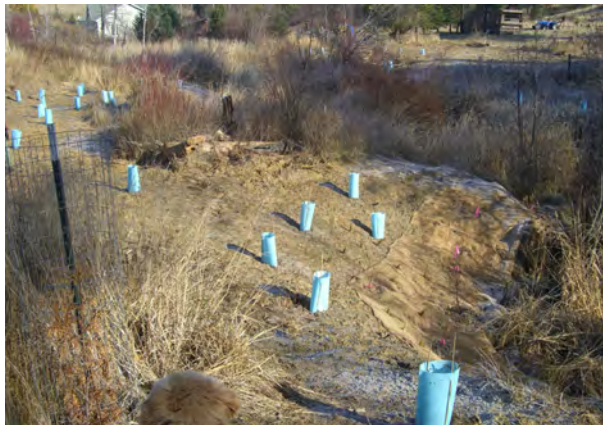
*October 2007: Steep banks throughout the project extent were resloped and stabilized with hydro-mulch and erosion control fabric. Following stabilization activities the site was planted with native trees and shrubs.*

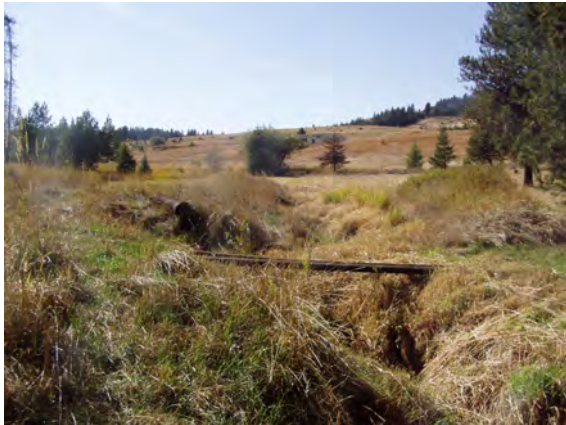
*September 2007: Photo point 3 upstream. Prior to restoration. Steep, unstable and actively undercutting banks throughout the restoration project.*

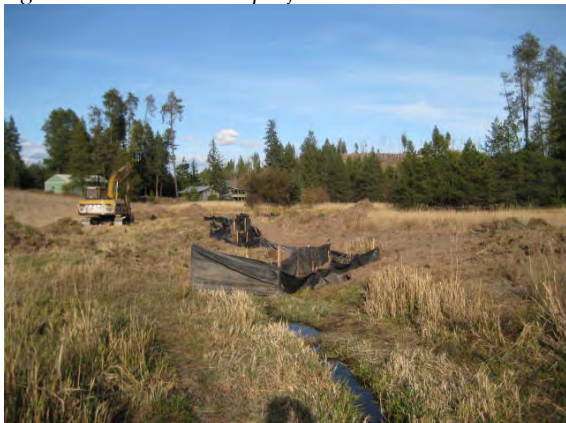
*October 2008: The banks of the Reynolds' property Flannigan Creek are resloped to minimize erosion. The black fencing helps to minimize disturbance to the creek from rollback and runoff in case of a rain event.*

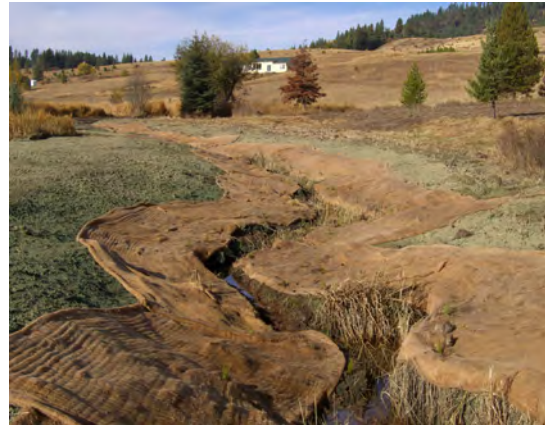
*October 2007: Photo point 3 upstream. Pos-construction banks were hydro-seeded with native grasses. Erosion control fabric helps stabilize banks.*

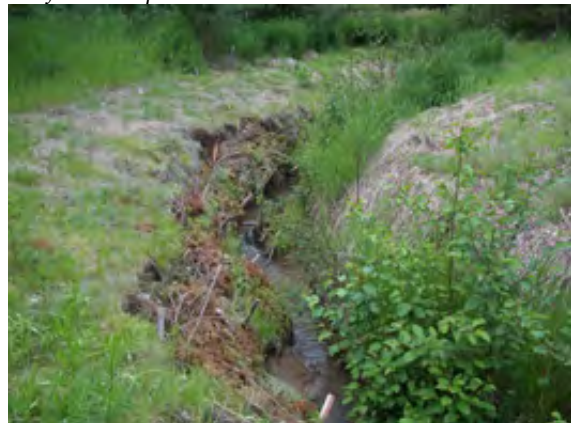
*August 2010: Brush revetment installed to reduce active in-stream erosion in areas on the bank that were difficult to access with excavating equipment.*
